RESERVE STUDY

BEACHMARK

CONDOMINIUM

Ocean City, Maryland

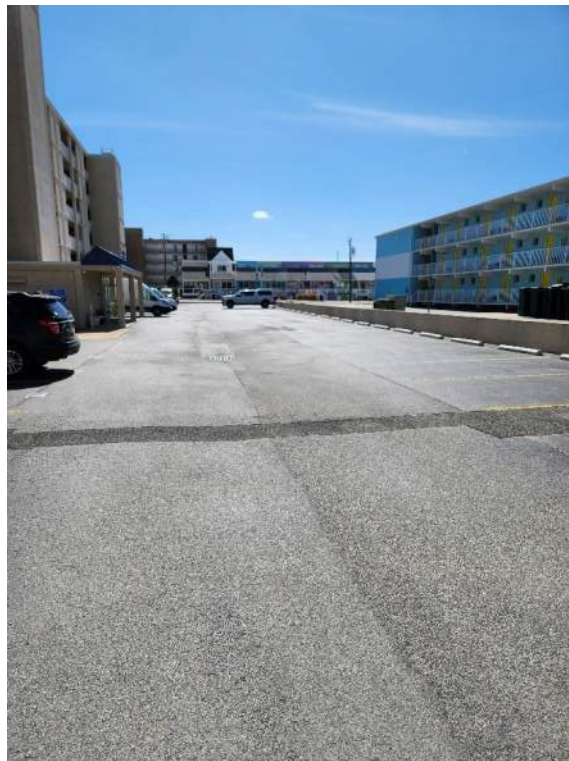
The overall condition of the asphalt pavement is **Fair**. No large cracks or settlement were noted in the pavement, and it appears to be wearing normally. Sealing coat is in **Poor** condition, as records indicate it was last done in 2005. Sealing cracks and applying seal coating is a good practice, as this can help prolong the life of the asphalt pavement. See below for additional recommendations to prolong the life of asphalt paving:

Photograph #2: Parking Area Asphalt

- **Seal Coating:** Seal coating the pavement every 5-7 years can extend the overall life of the asphalt. Prior to sealing the pavement, crack repairs and cleaning of the pavement shall be completed.

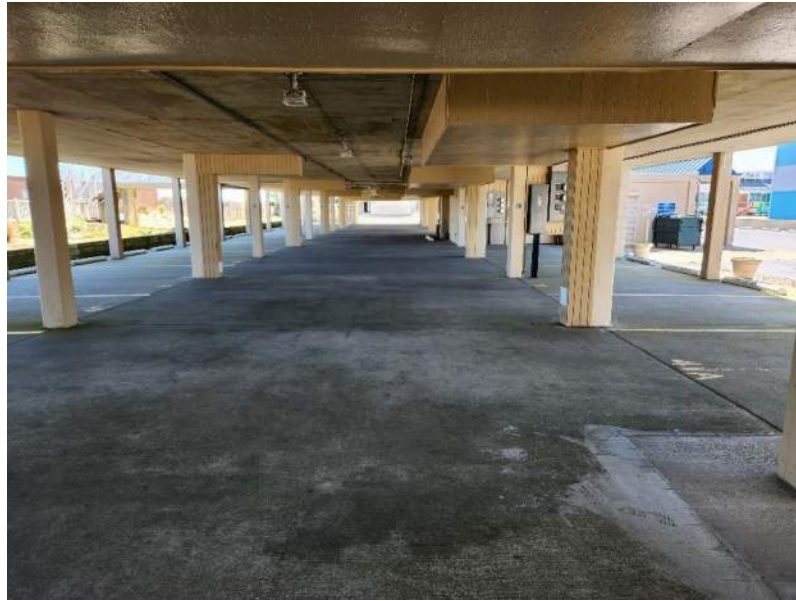
Concrete parking deck appears to be in **Fair** condition and wearing normally, with minor cracking in areas. Most of the concrete is showing wear consistent with its age. Building soffit has some areas of exposed rebar and should be repaired to prevent further damage.

Photograph #3: Parking Area Under Structure

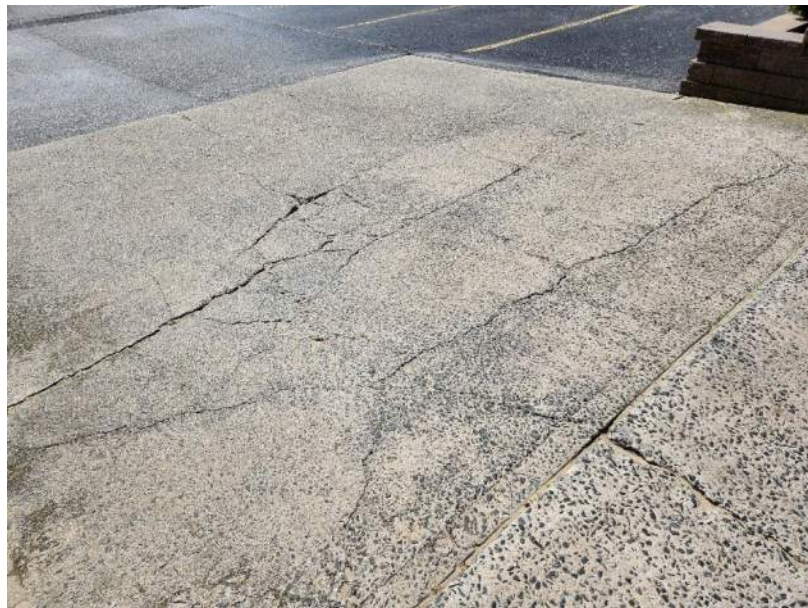
The condominium consists of many forms of concrete construction that include: concrete entrance slab, concrete entrance ramp to parking below building, and dumpster pad. The overall condition of the concrete work is **Good**. The entrance and ramp have some areas of cracking.

Photograph #4: North Entrance Slab Cracking

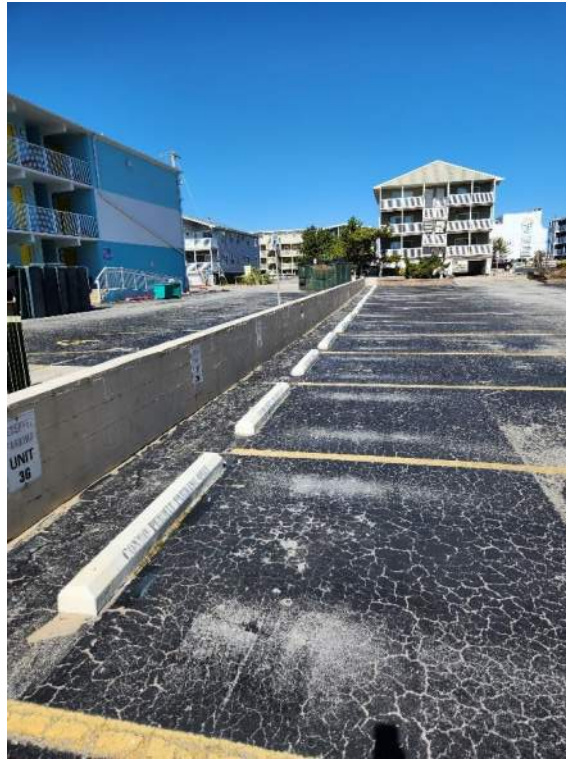
Block retaining wall is in **Fair** condition. Most of the block work appears to show signs of wear consistent with age, with most damage to wall cap.

Photograph #5: Parking Area Landscaping Wall

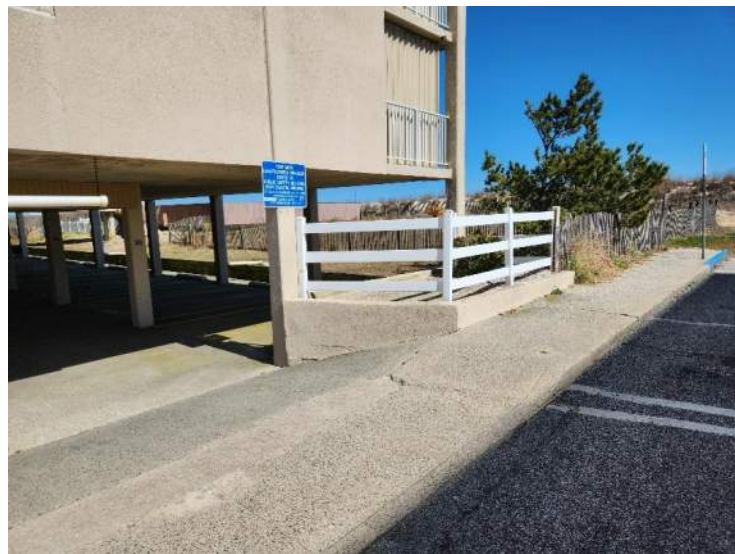
Photograph #6: South Entrance Ramp

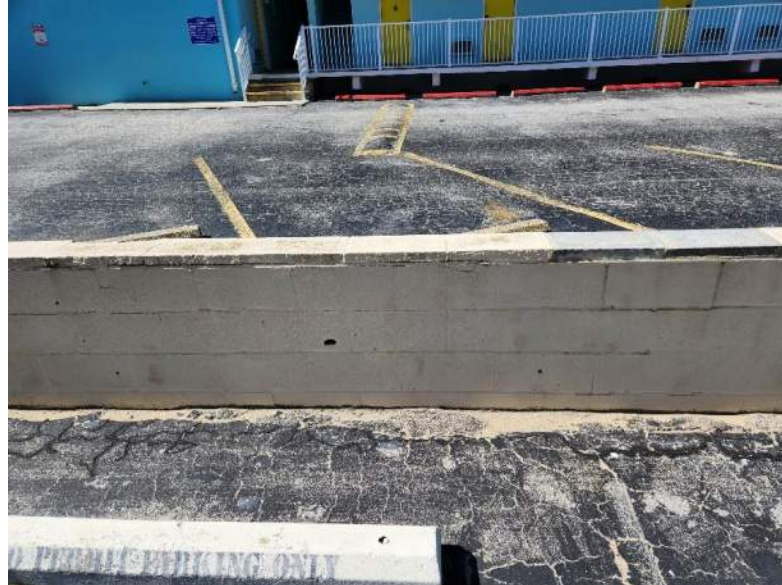
Photograph #7: Parking Area Landscaping Wall Cap Failure

1. Masonry Landscaping Wall Cap Replacement – CMU block divider wall observations show major damage to the wall cap. Replacement of the cap will prolong the life of the wall in order to prevent future damage of the courses below, due to water infiltration and freeze / thaw. Installation of wall expansion joints and recoating of the wall will help with prolonging the life of wall. We estimate replacement at \$10,000.
2. Concrete Repairs – Column cracking at southeast corner at balcony was observed. This is a major support column and should be repaired before future issues arise. We recommend investigation by an Engineer.
3. Elevator Tower Repairs – Elevator roof coping needs to be repaired to prevent future damage to walls. The lintel over the trash enclosure has corrosion and needs to be repaired to prevent future damage.

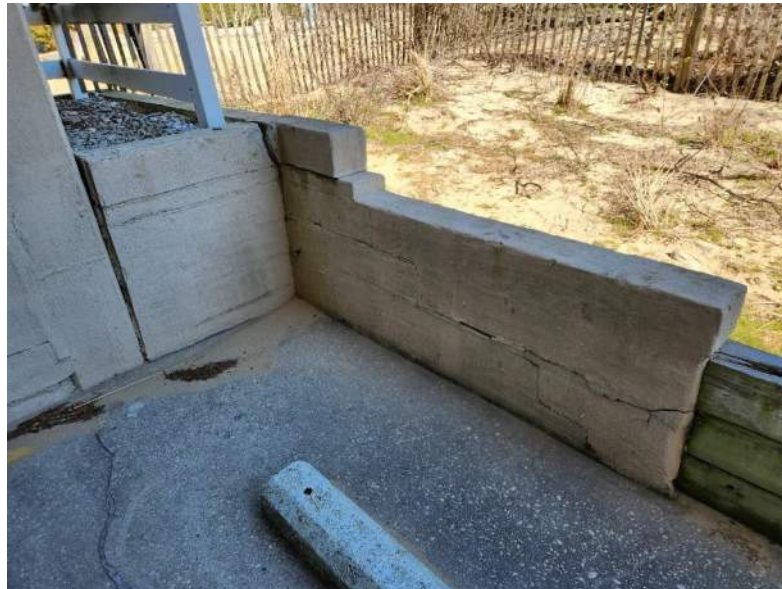
Retaining walls consist of concrete masonry units with painted stucco finish. Several cracks were observed that appear to be settlement cracks. Timber retaining wall is in **Good** condition and showing signs of normal wear due to age.

Photograph #8: Block Retaining Wall Cracking

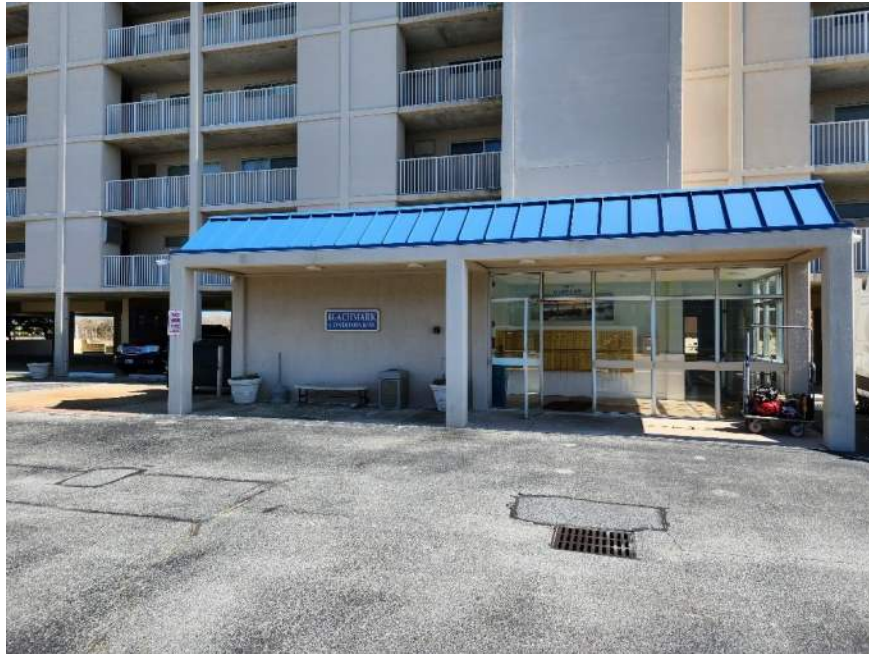
Photograph #9: Vestibule Aluminum Storefront

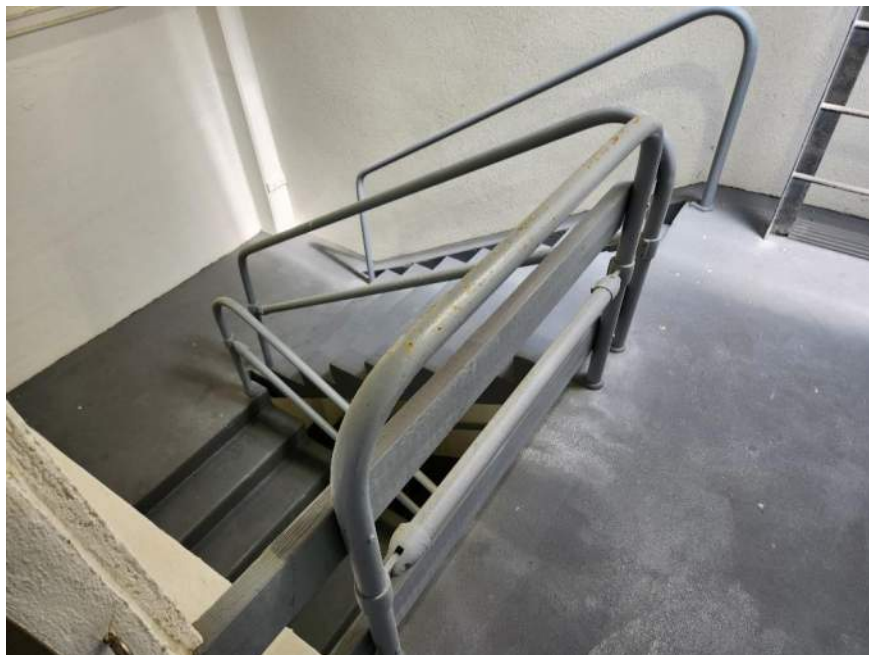
The building has coated aluminum railings in **Good** condition. The railings on the west side walkways were installed in 1997 and the east side balconies in 2004. The railings should be monitored for corrosion of the finish or loose attachments to the balconies. The stairwells have pipe painted guardrails that are in **Good** condition.

Photograph #10: Stair Railings

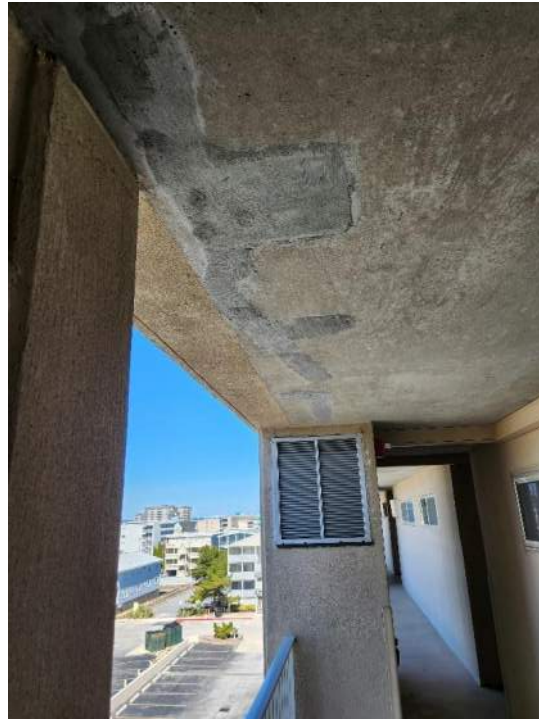
Photograph #11: Walkway Soffit Uncoated

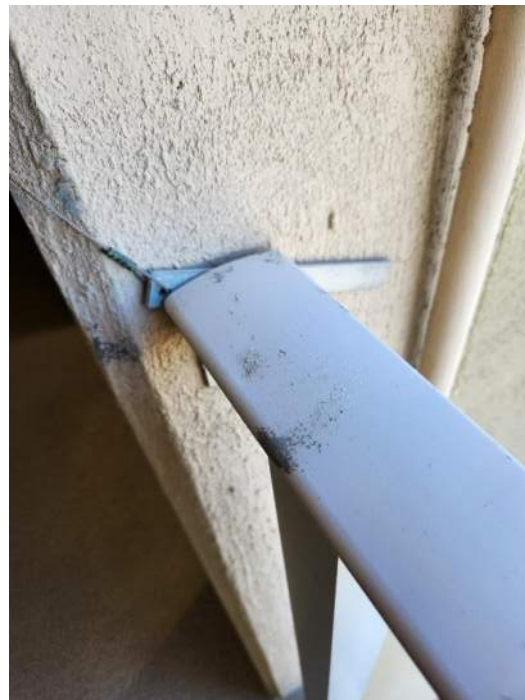
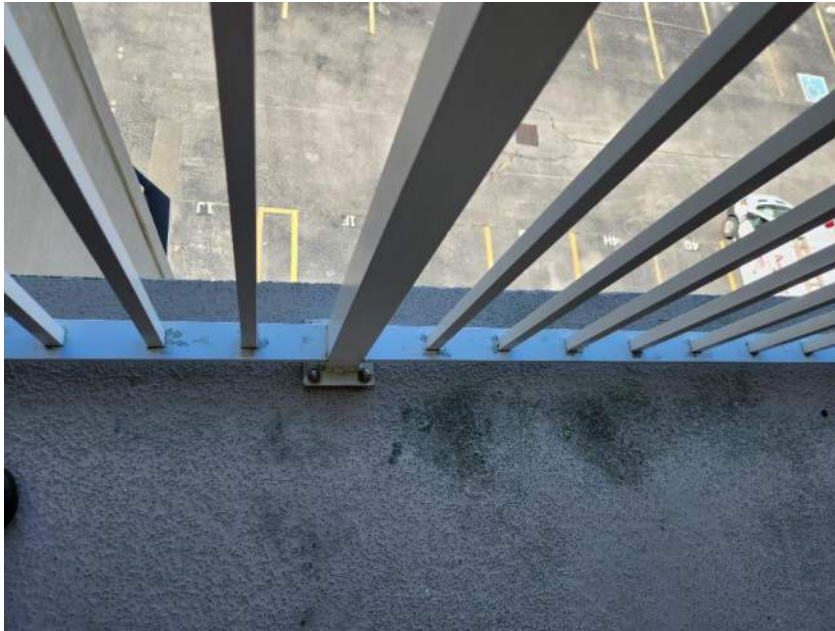
Photograph #12: Walkway Railing Coating

Photograph #13: Walkway Railing Coating

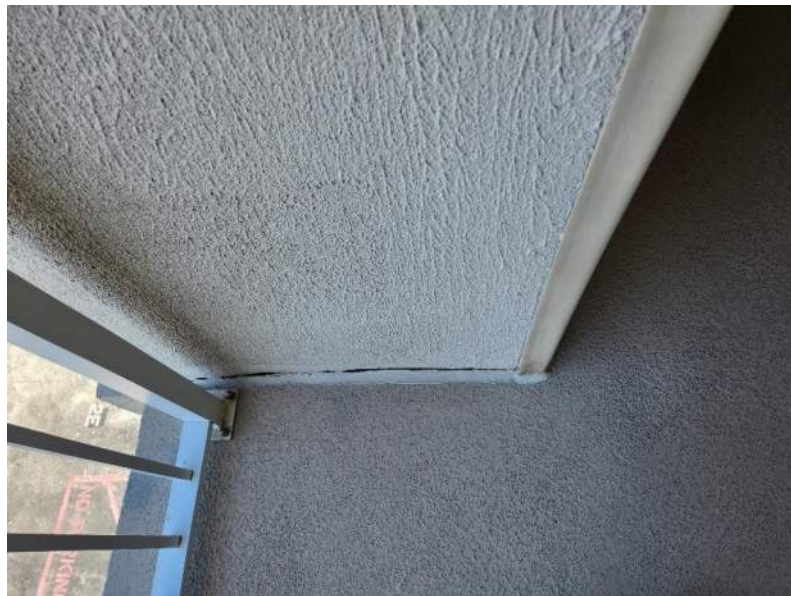
Photograph #14: Walkway Sealant Failure

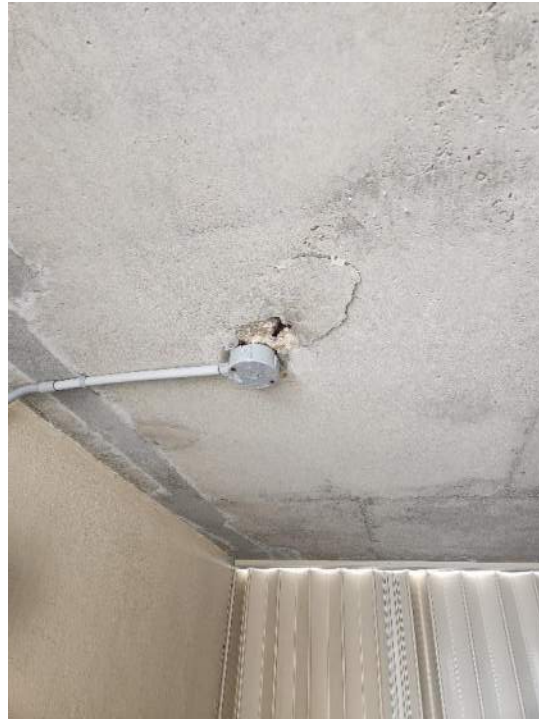
Photograph #15: Walkway Soffit Spall

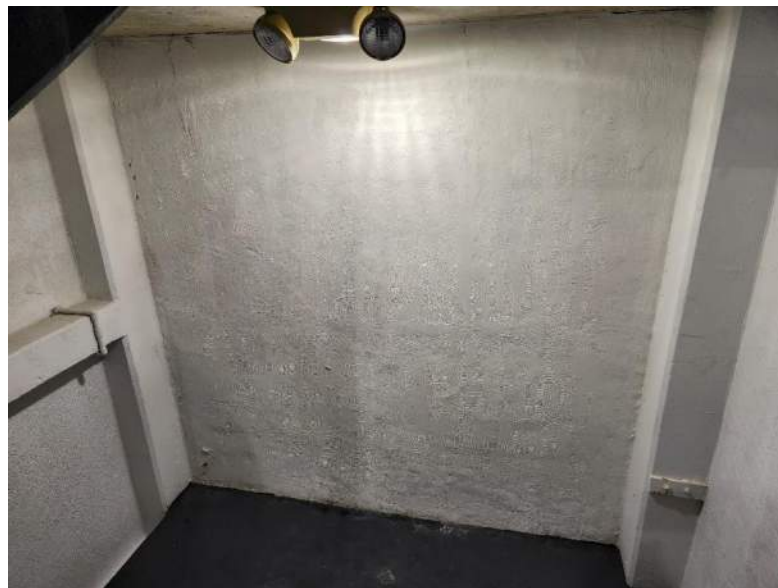
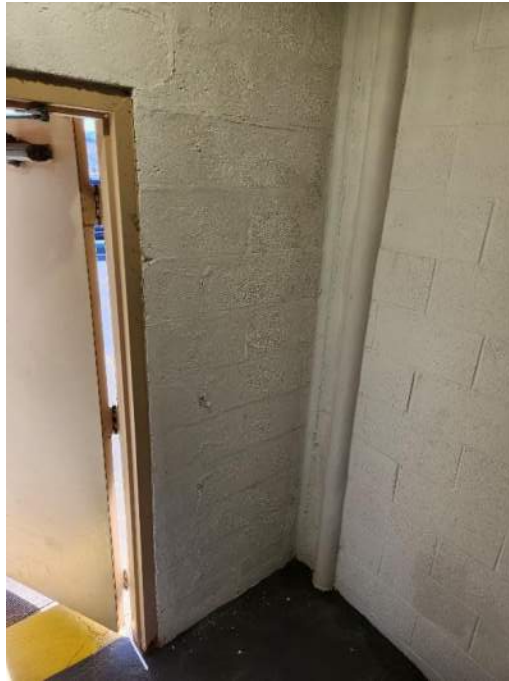
Photograph #16: Stair Tower Water Infiltration

Photograph #17: Stair Tower Water Infiltration

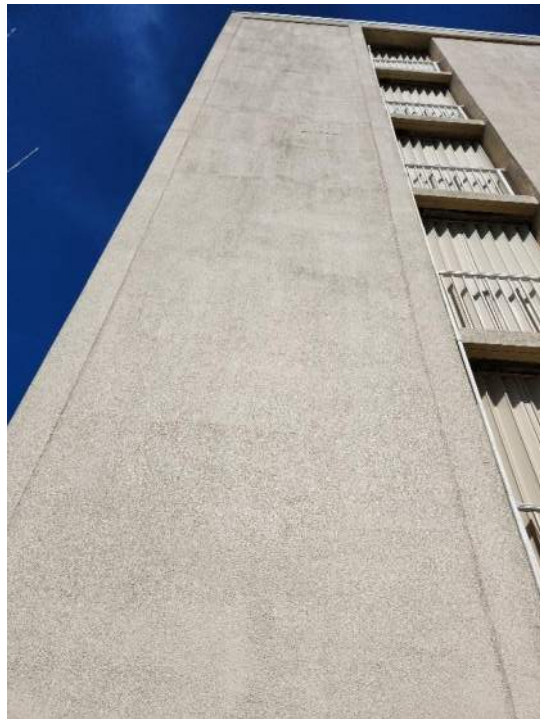
Photograph #18: South Façade Stair Tower Water Infiltration

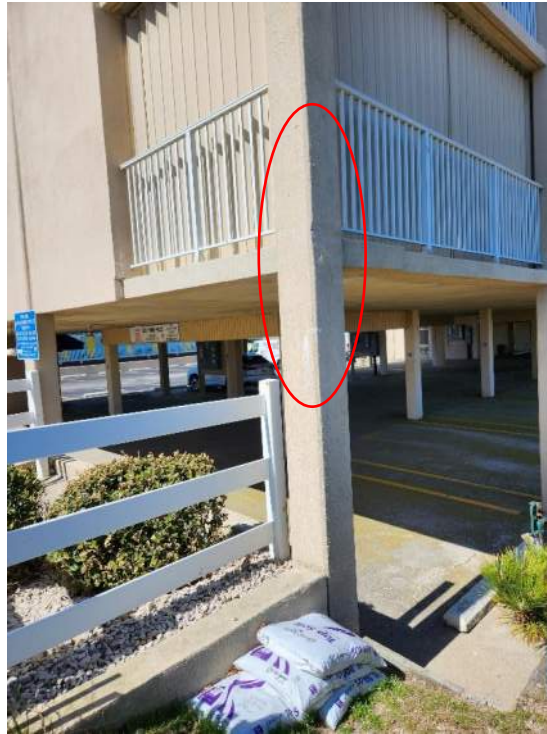
Photograph #19: Southeast Corner at Column Concrete Cracking

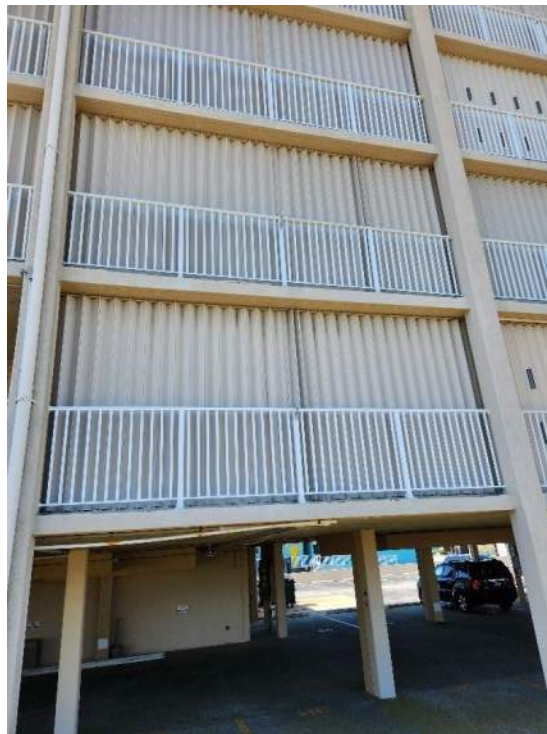
The exterior finish on the building is EIFS. The exterior finish was in **Fair** condition, only requiring typical recoating and replacement of caulking. There is record of a recoating on the north and south ends of the building, and the elevator tower in 2004.

Photograph #20: East Façade Coating Failure

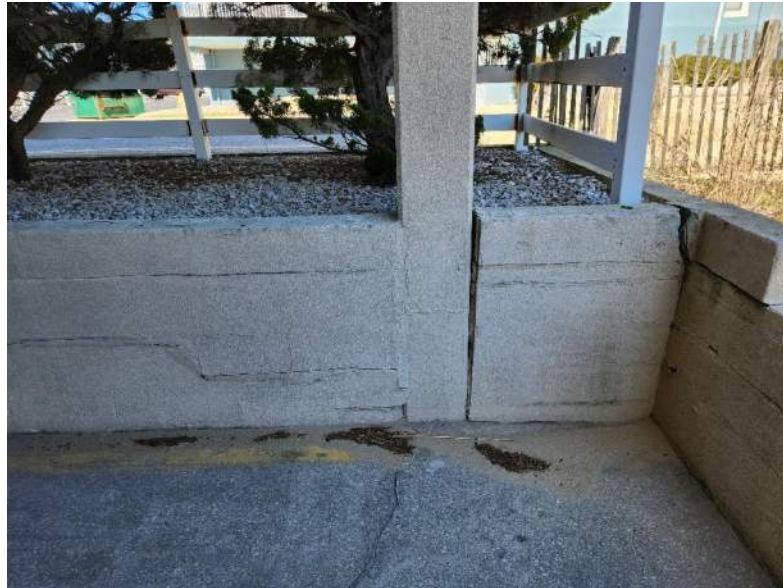
Photograph #21: Parking Area Retaining Wall Cracking

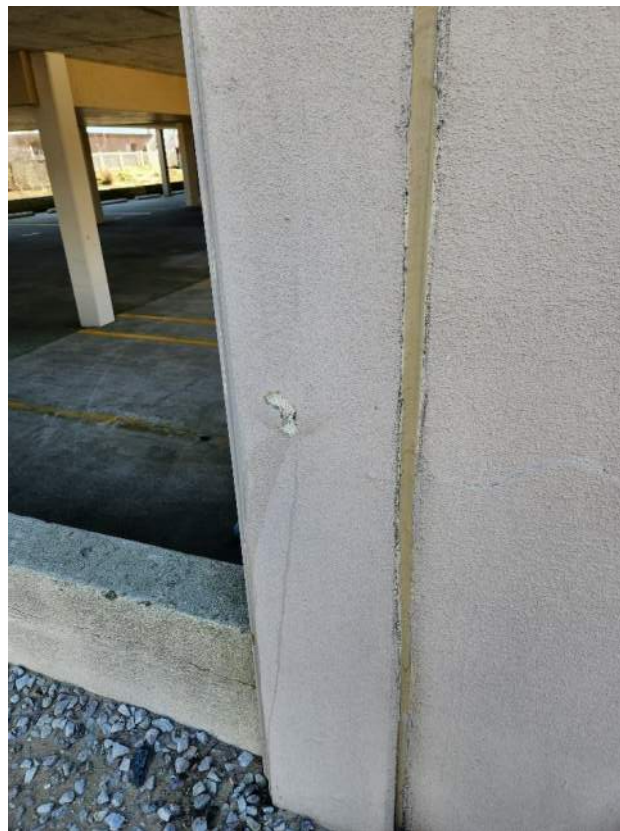
Photograph #22: North Façade Water Infiltration

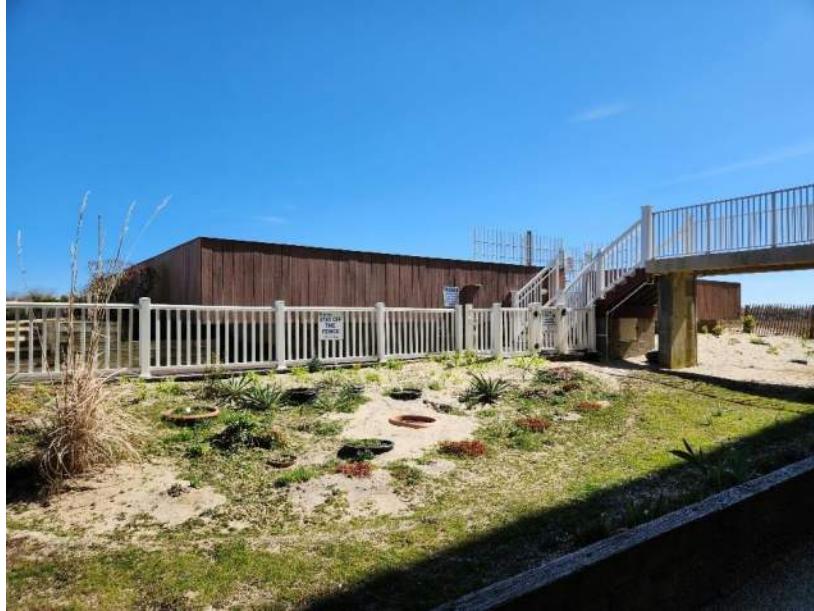
Wood framed stairs with composite treads from building walkway to pool / boardwalk area. In addition to wood framed boardwalk area with vinyl gate, fencing and timber retaining wall to beach access were installed sometime after the 2011 observation report. All items appear in **Good** condition. Boardwalk railing shows signs of minor damage to post caps and bases. Maintenance / repairs will be necessary over time.

Photograph #23: Pool Access Area

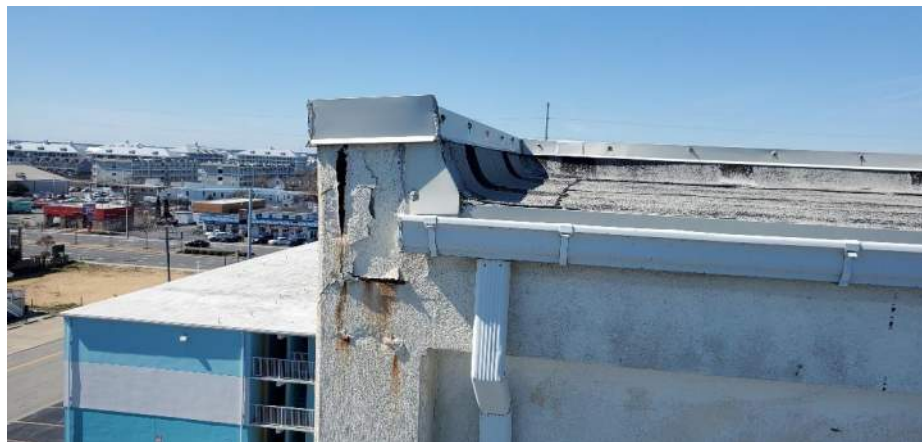
Photograph #24: Elevator Roof Coping Failure

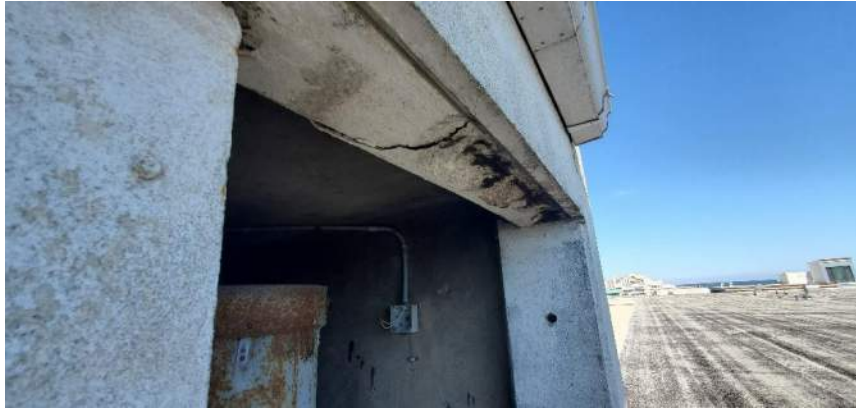
Photograph #25: Elevator Roof Lintel Failure
